# An Archaeological Curation-Needs Assessment for the Legacy Resource Management Program

Archaeological Curation-Needs Assessment Technical Report No. 15

U.S. Army Corps of Engineers St. Louis District

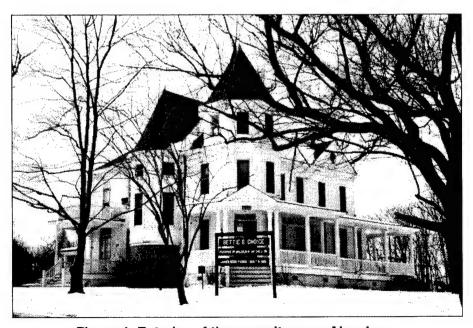
The Malcolm Mitchell House has been renovated to contain offices and exhibit areas managed by the Directorate of Safety, Health, and Environment. The foundation of the building is granite, the roof is imitation-slate tile, and exterior walls are Victorian-style wood clapboard. There are three floors aboveground and one belowground. Interior and exterior renovations are numerous. Walls and ceilings have been repaired and repainted. The gutter system, front porch ceiling, front porch pillars, and floor joints are all either additions or major modifications. The current roof is 15 years old. Overall, the structure is solid, with no cracks or leaks. There are multiple windows in the structure,

Figure 1. Exterior of the repository on Aberdeen.

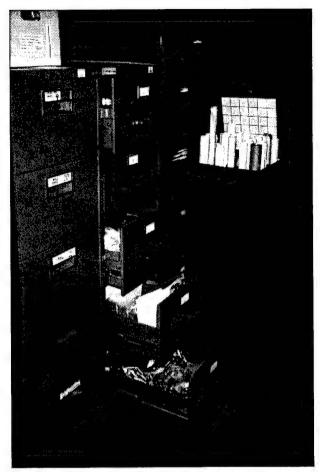
Figure 3. Some artifacts found on Aberdeen are stored in the drawers of metal file cabinets.

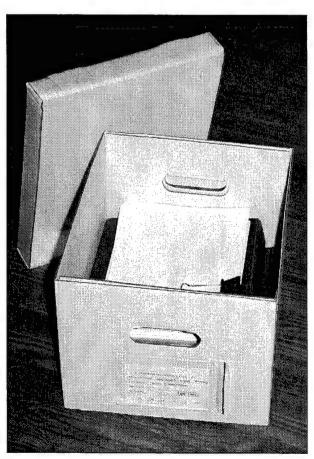
There are 12.5 linear inches of paper records, including excavation records, field notes, and artifact inventories. Primary containers consist of acid-free Hollinger boxes, labeled directly in marker with project, site number, contents, and box number (Figure 4). Secondary containers consist of acid-free envelopes and vinyl three-ring binders. Some paper stacks not enclosed in secondary containers are bound by metal clips, but are not labeled. Acid-free envelopes are not labeled. Vinyl binders are labeled with rub-on letters, covered with tape. Label information consists of project, contents, and copy number. Records are arranged by document type.

Figure 4. Paper records are stored in cardboard boxes on Aberdeen.

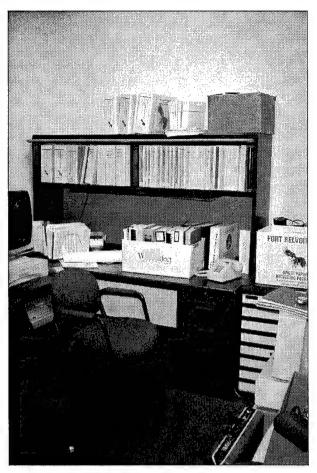
Approximately 4.6 linear feet of associated documentation from archaeological investigations conducted on Fort Belvoir are stored in an unused, approximately 10-x-10-foot (100-ft²) office at the DPW (Figure 6). All environmental controls for this room are the same as those for the remainder of the structure. There are functioning overhead pipes in this collections storage area that have leaked in the past. This collections storage area has no fire-suppression systems.

Figure 6. Associated documentation is stored in an extra office at the DPW.

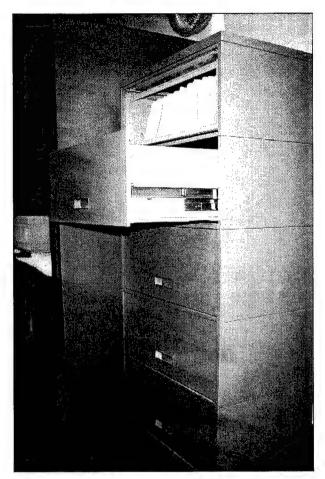
Figure 7. Active files are stored in hanging files in metal file cabinets at the DPW.

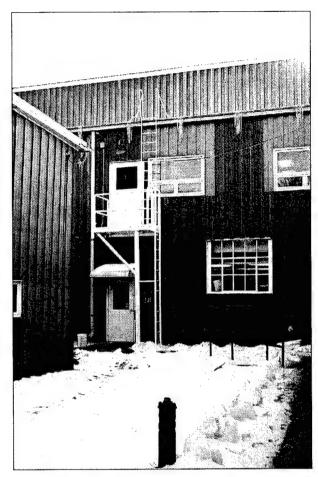
Building 201 was originally constructed in the 1930s (Figure 8). The foundation is concrete, and the approximately 5-year-old roof is built-up asphalt. Exterior walls are corrugated metal over asbestos board. Clay structural tile inside the exterior walls is also covered. The roof and foundation are solid, with no cracks or leaks.

Figure 8. Entrance to repository on Fort Detrick.

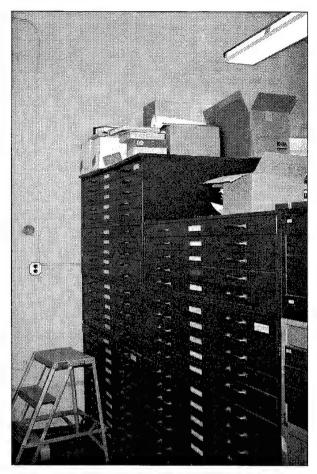
Archaeological collections are stored in a cardboard box located on the top of several 7-foot-tall, metal file cabinets in the rear of the collections storage area (Figure 9).

Figure 9. Collections are stored in a box on top of the highest of the flat map cabinets.

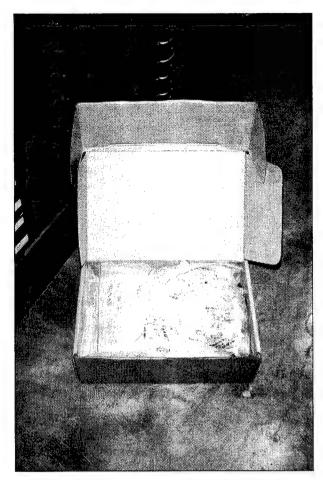
Secondary containers consist of zip-lock, 4- and 6-mil polyethylene bags. Bags are labeled directly in marker; label information consists of installation, site number, and provenience (Figure 10). There are multiple tertiary containers, all of which are zip-lock, 4- and 6-mil polyethylene bags. Tertiary containers are labeled in an identical fashion to the secondary containers, except that some contain acid-free-paper tags labeled directly with marker. Label information is the same: installation, site number, and provenience.

Figure 10. An open acidic-cardboard primary container reveals zip-lock plastic bags used as secondary containers on Fort Detrick.

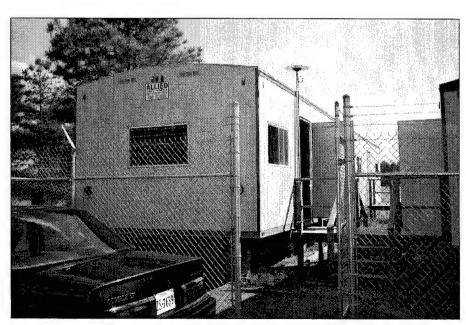
Storage Location 2 is a standard trailer-housesized structure made primarily of corrugated metal (Figure 12). It rests on concrete blocks. There is one floor, with a set of wood steps leading up to the two exterior doors. There are multiple

Figure 12. View of Storage Location 2, a rented trailer, where associated records are stored.

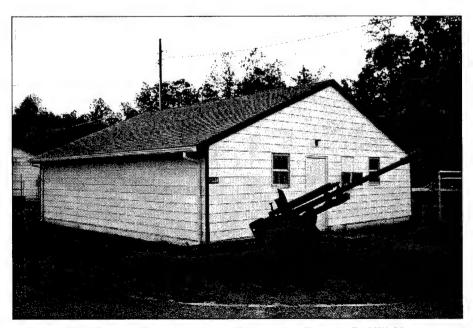
The Fort A. P. Hill Museum, Storage Location 3, is a small, one-room facility located in the main cantonment area of the installation (Figure 13). Although originally used as a Class 6 (liquor) store, it was later converted into a museum. The foundation is poured concrete and concrete block. Exterior walls are constructed of aluminum siding over wood. The roof, composed of shingles, is original to the building.

Figure 13. View of Storage Location 3, the Fort A. P. Hill Museum.

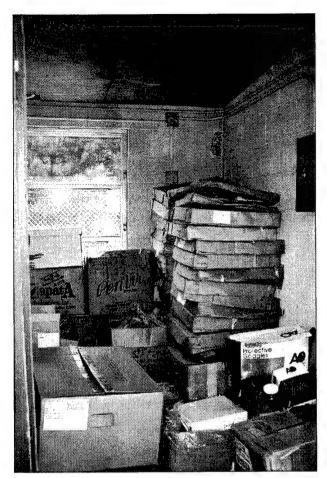
Boxes of artifacts are stacked on the concrete floor of Storage Location 1 (Figure 15). In Storage Location 3, artifacts are exhibited in a wood-and-glass storage case measuring  $3.1 \times 1.1 \times 3.4$  feet (w × d × h).

Figure 15. Damaged artifact boxes are stacked against the wall in Storage Location 1.

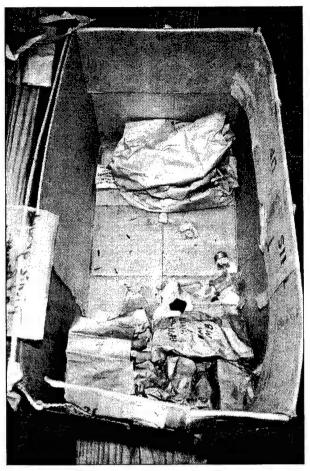
Figure 16. Example of an interior of a primary container used on Fort A. P. Hill. Note the broken artifacts loose in the bottom of the box.

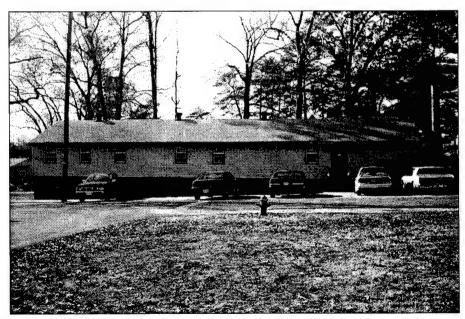
Building 239, which encompasses approximately 2,125 ft<sup>2</sup>, is not an official repository (Figure 17). Activity areas in the structure include offices, a reception area, a conference area, and rest rooms. Collections are currently being stored in the closet within one of the offices.

Figure 17. Exterior of Building 239, Fort Meade's environmental offices, where collections are stored.

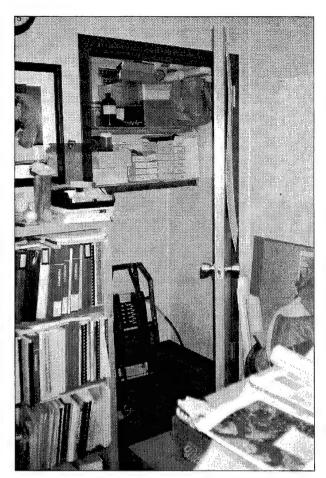
Figure 18. Office closet used for the storage of artifact and record collections on Fort Meade.

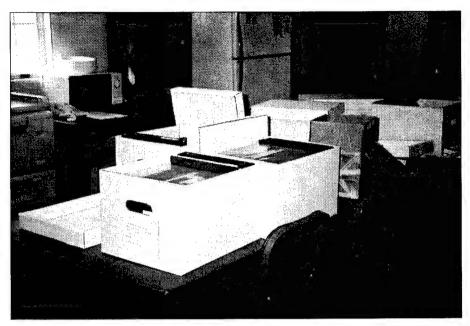
Approximately 3.4 ft<sup>3</sup> of artifacts recovered on Fort Meade are stored in acid-free Hollinger cardboard boxes with telescoping lids (Figure 19). These boxes are labeled with contents, site number and provenience. Labels are acid-

Figure 19. Cardboard boxes are used as primary containers for artifacts and associated documentation on Fort Meade.

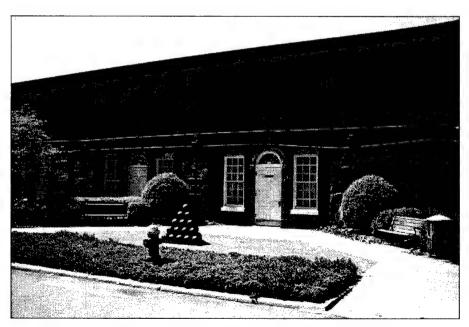
The original fortification dates to the period 1818–1834. The foundation and exterior walls are primarily composed of brick and stone. Bricks have been removed from several sections of the fortification roof and been replaced with poured concrete. On many original sections, however, roofing remains composed of bricks that are covered with earth. The museum has had multiple renovations and expansions since 1951, the latest during 1982–1983 when several rooms were added. There is only one floor for the entire fortification. Multiple windows are present in the inward-facing walls of the museum, and approximately one-third as many face outward to the fort's exterior. Windows and their frames were replaced approximately two years prior to the assessment team's site visit. The structure is solid, but there are multiple cracks in the brick walls and roofs. In addition, there is some water seepage from the brick roof, where it is overlain by earth.

Figure 20. Exterior of the Casemate Museum, Fort Monroe.

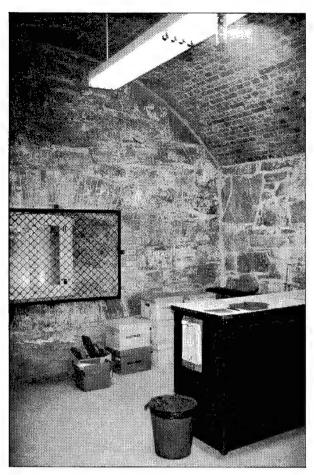
Figure 21. Collections storage area for arms within the Casemate Museum.

The collections storage area is a series of casemates separated from the offices and exhibit sections of the museum by a wood-panel door (Figure 21). Total space for collections storage measures 3,600 ft², and includes four casemates and one arms room. The arms room is separated from the collections storage area by a metal-panel door. The interior sections of the collections storage area are divided by brick archways. There are four wood-panel doors in the collections storage area that open to the exterior of the museum. The collections storage area is filled to approximately 90 percent capacity with archaeological and ethnographic collections, each composing approximately one-half of the materials.

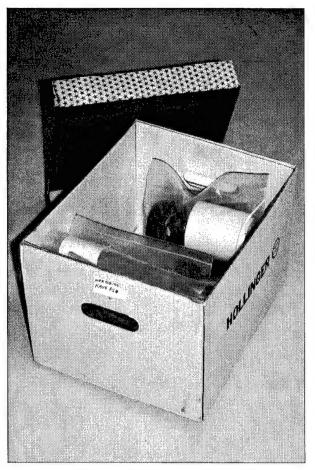
Figure 24. Cardboard boxes and zip-lock plastic bags are used to store artifacts on Fort Monroe.

Within the moat collection, secondary containers are either not present or consist of acid-free-construction-paper dividers or Styrofoam "peanuts." Secondary containers for the survey collection are either not present or consist of zip-lock plastic bags (Figures 24 and 25). The zip-lock plastic bags generally have interior, acidic-paper tags with provenience recorded in pen. Table 8 outlines the percentages of secondary-container types in the on-base collections.

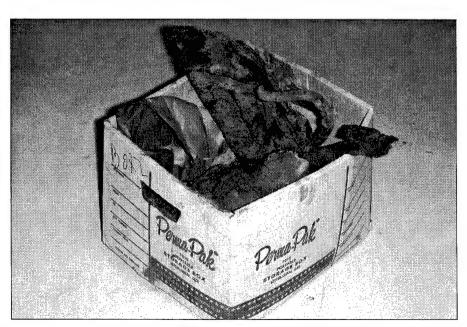
Figure 25. Oversized metal artifacts are stored loose within a cardboard box.

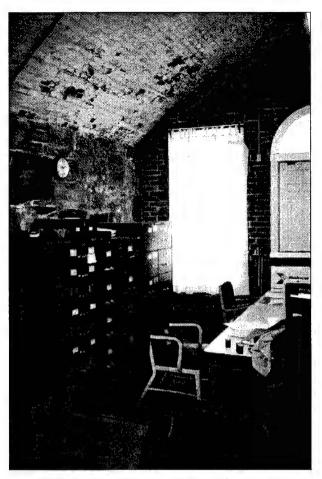
Files are cross-indexed by donor's name, catalog number, and subject matter (Figure 26).

Figure 26. Office area in the Casemate Museum where unassociated records are stored in metal file cabinets.

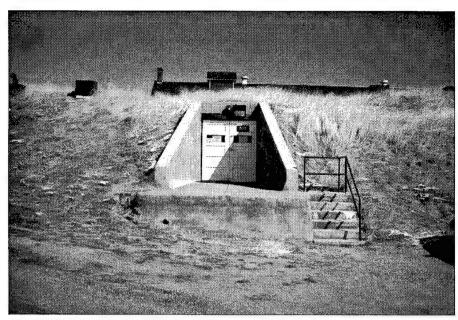
Figure 27. The entrance to Building 261, the curation facility on Warren AFB, appears to lead into a hill. Approximately 3 feet of earth cover this facility.

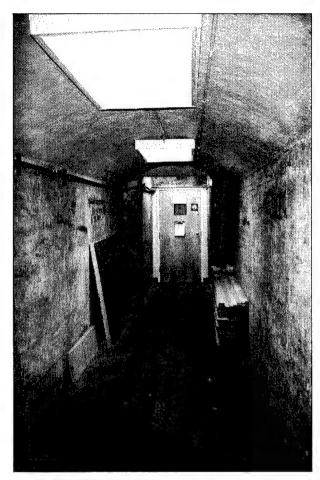
Figure 29. The exterior door of Building 261 leads into a concrete tunnel that has a second locked door securing entrance to the curation facility. The concrete walls have graffiti dating to 1907 that was discovered during the rehabilitation of the facility in 1992.

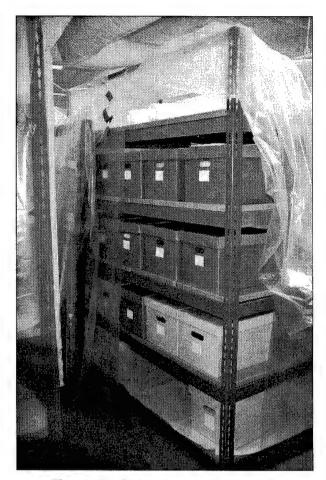
Figure 30. Collections are stored in cardboard boxes on metal shelving units in Collections Storage Area 2. Note that some of the shelves are lined with sheets of ethafoam and covered with heavy sheets of plastic to protect against dust.

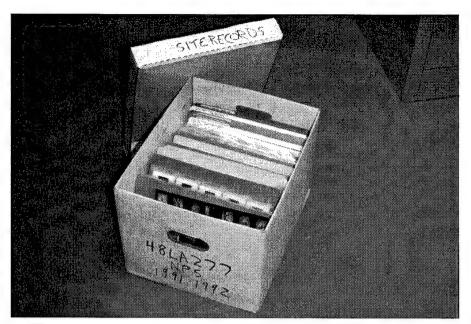
Figure 32. Some of the associated records for Warren AFB have been placed in cardboard boxes and are stored on metal shelving units in Collections Storage Area 2.

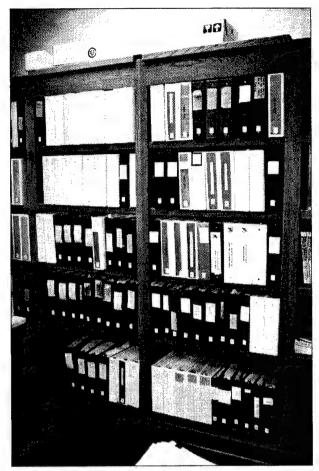
Figure 33. Associated documentation from projects conducted on Warren AFB is stored in plastic-covered three-ring binders on wood shelves in Collections Storage Area 1. Binders are numbered with white adhesive labels.

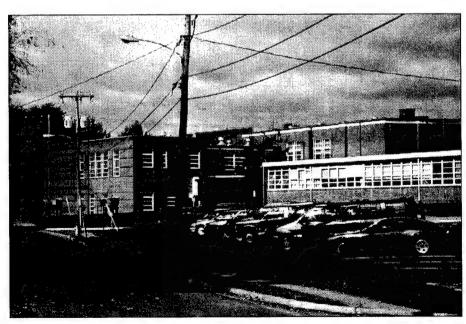
The structure that houses FCAS is approximately 50 years old. It has a reinforced-concrete foundation and brick exterior walls. The flat roof has leaked in the past, but the leaks have all been repaired. The roof was renovated two years ago. There is some evidence of water damage to the structure, but this too has been repaired. The floor is concrete, with peeling asbestos tiles. The ceiling is reinforced with steel and poured concrete. The repository has a total of two aboveground floors, with the archaeology labs and Collections Storage Areas 1 (Figure 35) and 2 on the first floor and Collections Storage Area 3 on the second floor. Windows are in their original metal frames and are located on all sides of the structure. There is some indication that air leaks into the building through the windows.

Figure 34. Exterior view of FCAS, which is located in the left portion of this building.

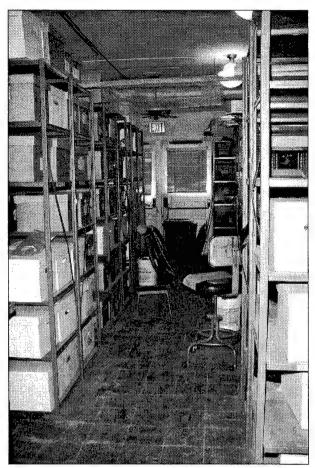
There are two windows on the east wall, each of which measures approximately  $9 \times 6$  feet. Venetian blinds are kept drawn. The interior door is constructed of wood panels. Plywood covers a preexisting window. Dust covering the floor, shelves, and boxes apparently originates from buckets of unwashed artifacts stored in this room.

Figure 35. Collections Storage Area 1 is crowded with boxed collections and field equipment. A significant amount of dust covers the peeling asbestos floor tiles. The back, exterior door is kept locked.

No integrated pest-management program is in place for FCAS. The facility is sprayed and fumigated on a quarterly basis. Staff members indicated there are no insect or rodent problems; St. Louis District personnel, however, noted a significant insect infestation on the windowsills of Collections Storage Area 1.

- 1. The repository contains a large quantity of asbestos floor tiles that could be a health hazard to staff and outside researchers.
- 2. The staff has noticed large temperature fluctuations in the collections storage areas.
- 3. No UV filters are present on any of the light sources.
- 4. The accumulation of dead insects on windowsills is indicative of a possibly inadequate pestmanagement program.
- 5. Fire-detection and -protection systems in the collections storage areas are inadequate.
- 6. Artifact collections at FCAS, although stored in an orderly manner, require more space than is

- 1. Remove and replace asbestos tiles immediately.
- Install an HVAC system with an advanced dust-filtration system.
- 3. Equip all light fixtures in and near collections storage areas with UV filters.

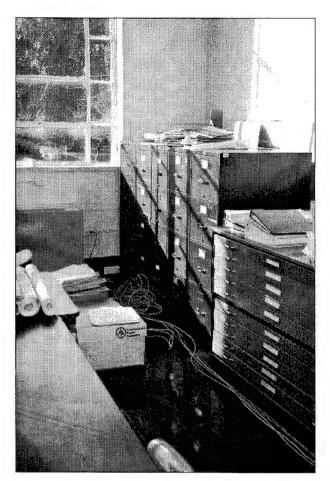
Prehistoric-site files are stored in a legalsized, metal file cabinet. Historical-period files are in a letter-sized cabinet (Figure 37). Labels on the secondary containers range from being directly written on in marker to adhesive labels with information written in pencil. Manila folders are used to file paper and photographic records.

Figure 37. Associated records for historicalperiod sites are stored in metal file cabinets located upstairs in an office and lab area (Collections Storage Area 3).

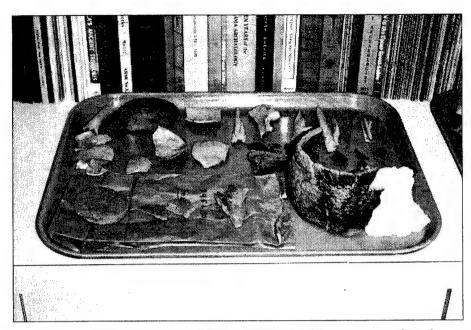
Although normally stored in Storage Location 2, some Radford artifacts were temporarily housed at the museum, in Dr. Benthall's office. The artifacts had been removed from the storage containers in Storage Location 2 and brought to Storage Location 1 for our inspection. The artifacts were on a plastic cafeteria tray (Figure 40) and a cardboard, telescoping box lid that were

Figure 40. Artifacts recovered from Radford laid out on a cafeteria tray in Storage Location 1.

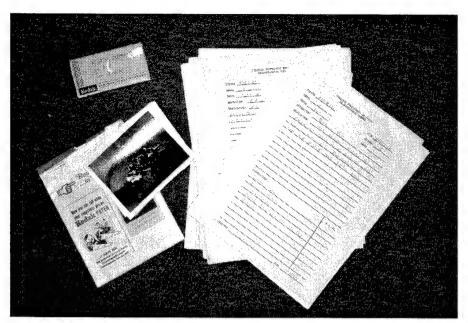
Figure 41. Associated documentation is kept in an acidic envelope that is stored in a file cabinet at FLSHA.

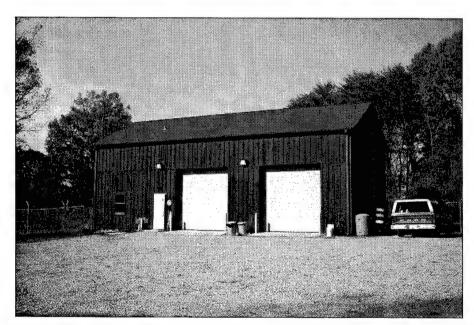
Figure 42. Exterior view of Storage Location 2, the maintenance building, at FLSHA.

concrete block; the exterior walls are cinder block with wood siding. The shingled roof is original to the structure. No problems with water leakage through the roof have been reported.

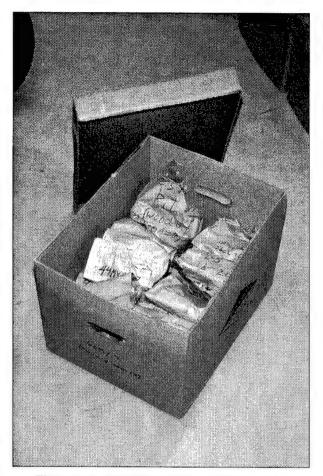
Most secondary containers in Storage Location 2 are zip-lock plastic bags with labels written directly on them in marker and pen (Figure 45). A few plastic film canisters are also used. Acidic tissue paper is used as padding. Some of the plastic bags are torn and should be replaced (see Table 13).

Figure 45. Cardboard boxes and paper bags are the primary and secondary containers used to store the artifact collections recovered from Radford.

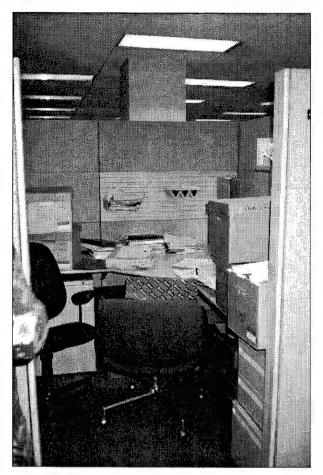
Figure 47. Associated records are boxed and stored in an extra office cubicle in Storage Location 1.

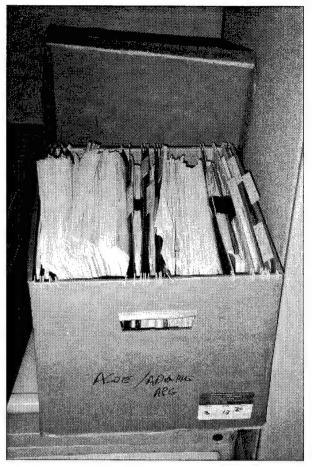
Figure 48. Associated documentation is filed and stored in a cardboard box in Storage Location 1.

Records are stored by project. Associated records for the Adelphi Labs survey are stored in an acidic-cardboard box similar to the one used for artifact storage (Figure 47). The label is written directly on the box in marker (Figure 48). Records are filed in acidic, hanging files within the box. All of the records are in generally good condition; however, duplicate copies have not been produced. Some of the field notes still have dirt and dust on them, and contaminants (e.g., staples, paper clips, and rubber bands) are present on the original documentation.

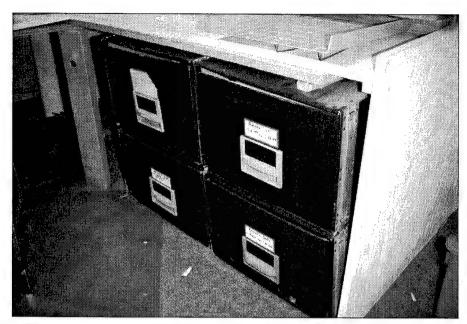
The archaeological documentation associated with Bloodsworth Island NR and Blossom Point is stored in acidic-paper file folders and envelopes, which in turn are filed in stacked cardboard storage units that are sitting directly on the carpeted floor of the small storage room (Figure 53). Documentation totals 29.25 linear inches, of which 13.5 linear inches are associated with Bloodsworth Island NR, and 15.75 linear inches are associated with Blossom Point.

Figure 53. Cardboard storage units are used to house associated documentation at GRI.

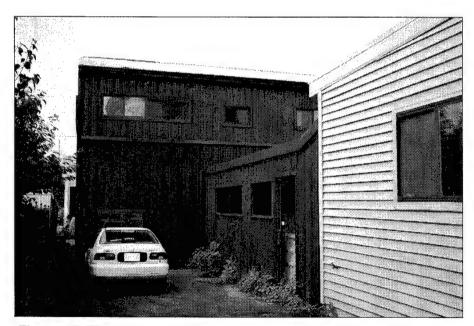
Figure 56. The recent addition to the rear of the offices of Goodwin is used as the collections storage area.

company continually monitors the system. Locks and intrusion alarms are located on all exterior doors. Security risks compromising the collections' security do exist, however. Windows are numerous and are protected by only simple window locks; there are two such windows in the collections storage area. One door in the causeway between the older house and the most recent addition to the repository is glass. In addition, the two hollow core wood doors separating the collections storage area from the rest of the repository have no locks. There have not been any episodes of unauthorized access in the past.

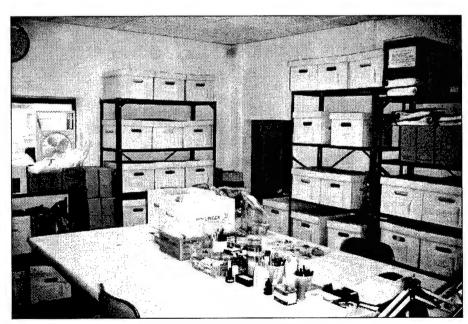
Figure 57. View of the collections storage area and laboratory at Goodwin. Boxed collections are stored temporarily on metal shelving units until they are sent to a permanent repository.

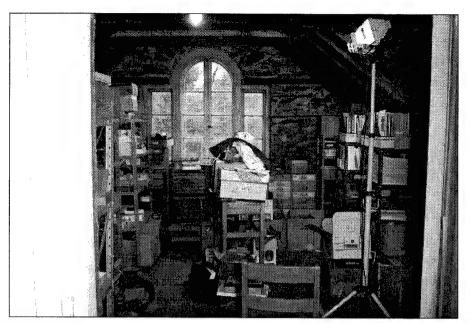
The building's environmental controls are maintained by the county school system. A custodian for the buildings lives on the property. Harford Glen Mansion is equipped with an oil and hotwater radiator heating system; however, the attic where the collections are stored is not heated. There are no humidity monitors or controls for the facility. Lighting in the collections storage area is provided by natural light through the attic window, an overhead light fixture with an incandescent bulb, and a free-standing mount with two halogen bulbs. UV filters are not used. The collections storage area is cleaned as-needed by members of HCAS.

Figure 64. View of the mansion's attic where collections recovered from Aberdeen are stored. Note the borrowed, free-standing halogen lights used to help illuminate the room.

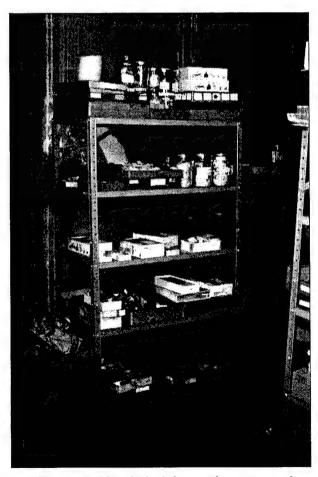
Approximately 26 ft<sup>3</sup> of archaeological artifacts and human skeletal remains recovered from Aberdeen are stored in a variety of containers including acidic-cardboard boxes without lids, glass mason jars, plastic pencil boxes, wood cases, plastic vials with lids, and glass Riker boxes. The containers are arranged haphazardly on the shelves, making the identification of

Figure 66. Metal shelving units are used to hold the variety of primary containers storing the Aberdeen collection.

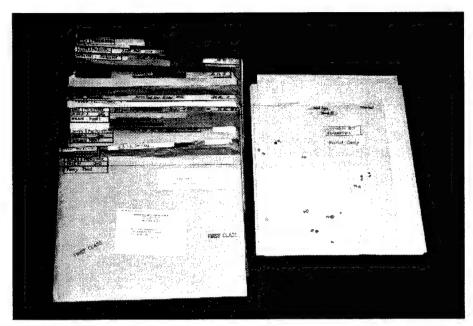
Figure 67. Original paper records associated with Aberdeen sites are filed in acidic envelopes and labeled with Cresthull's unique numbering system.

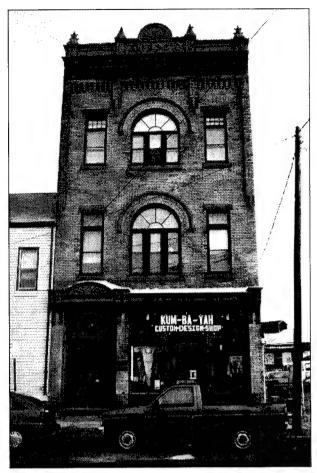
The building has a stone foundation and brick exterior walls. The type of roof is unknown. It has not been replaced during the seven years that HRA has been there. The building has a total of four floors, three are above grade and one below grade basement. Windows of various shapes and sizes are on all sides of the building and most of them do not have shades. The wood frames have never been replaced; however, personnel have never experienced any drafts or water leaks.

Figure 68. Exterior of building where HRA offices are located.

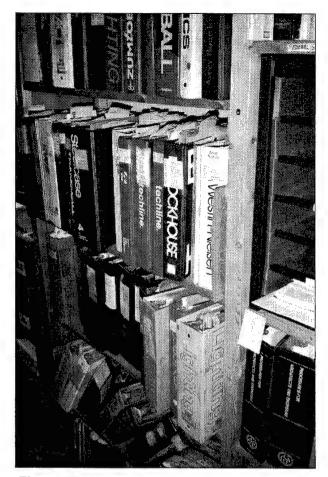
Negatives, slides, and contact sheets (1 linear inch) are housed in three-ring binders that are stored on wood bookshelves in the second floor hallway, Collections Storage Area 2 (Figure 69). Photographs are labeled with the project number.

Figure 69. A variety of three-ring binders are used to store photographic materials at HRA. The binders are arranged on wood shelving units in the second floor hallway.

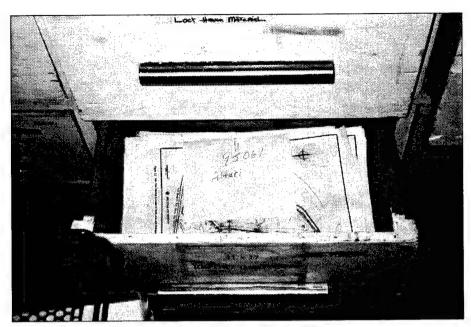
Two linear inches of large maps are stored on the third floor in Collections Storage Area 3. A flat map case is in the corner of an open work area; however, most maps are kept rolled on top of the map case. The Adelphi Labs maps are rolled and kept together with a rubber band. Small maps generated for the reports are stored in wood drawers beneath the large lab table in Collections Storage Area 4 (Figure 70).

Figure 70. Wood drawers beneath the lab table are used to store small maps at HRA.

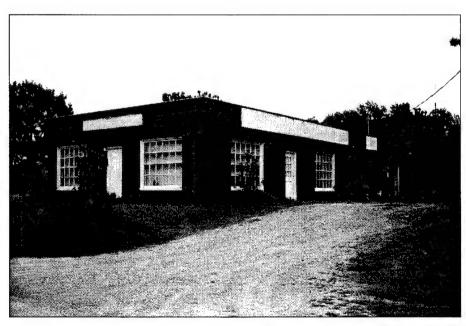
The facility has a structurally sound foundation and exterior walls. The roof occasionally leaks over the laboratory area, but not over the collections area. There are five windows in the building, all with wood frames. All windows but the south-facing one in the collections storage

Figure 71. View of the JRIA repository.

Figure 72. View of the laboratory and collections storage area at JRIA.

- 6. A leaking air conditioner damaged carpet and tiles in the entranceway to the collections storage area. Further leaking could damage the collections. There are also signs of roof leakage, as evidenced by water-damaged ceiling tiles in the collections storage area.

- 4. Repair leaking air conditioner and any leaks in the roof.
- 5. Install an HVAC system, if feasible; if not, monitor humidity with a sling psychrometer or hygrothermograph and install a commercial dehumidifier.

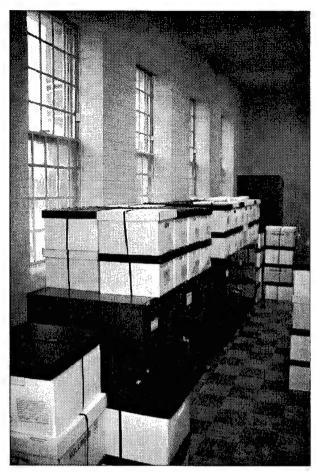
The floors in the collections storage areas are concrete, covered with tile (Figure 75). Interior

Figure 75. This collections storage area in Storage Location 1 is used for select artifact collections and overflow storage of collections.

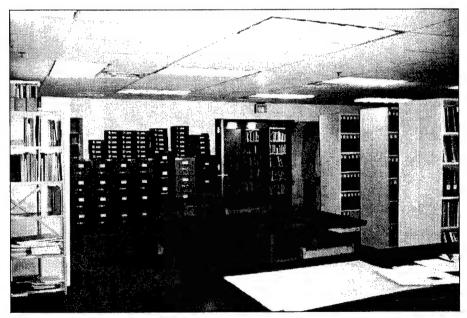
Figure 77. View of the records storage room and study area in Storage Location 2.

study (Figure 77), and library areas. The Maryland site files are located in this area. The floor is concrete overlain with carpet. Interior walls are wallboard/Sheetrock, and the ceiling has suspended acoustical tiles. There are no exterior

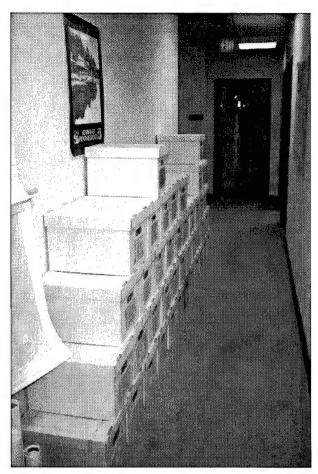
Figure 82. Boxed artifact collections are stacked along the wall in the hallway at Milner.

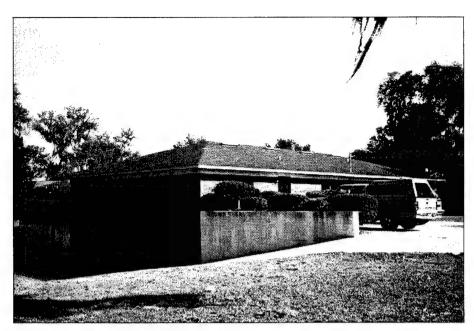
The building is approximately 10 years old, with a slab concrete foundation and brick over frame exterior walls. The roof is composed of asbestos shingles; it is the original roof of the building. No cracks or leaks are present in the roof or foundation, and although tornadoes and hurricanes are common to the area, weather has not affected the building. The repository has one floor above grade and a basement under one half of the building that has an exposed wood-beam ceiling, concrete floor, and cinder block walls. Interior dividing walls in the collections storage area are made of plywood. The windows in the upper level offices have aluminum frames. One window pane has been replaced. No major renovations have been performed on the building since it was built.

Figure 85. View of the shared office building where the SouthArc offices are located. Note the partially below-grade level that is used by SouthArc for the temporary storage of artifact and unassociated records collections.

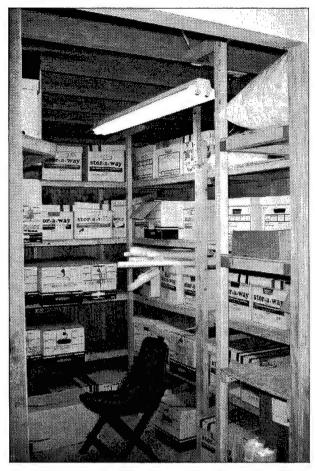
Archaeological collections are stored on untreated-wood shelving units measuring  $1.3 \times 1 \times 0.8$  feet ( $1 \times w \times d$ ) and running along the walls of the basement collections storage area (Figure 86). The area is filled to approximately 90 percent capacity. Refer to Table 28 for a breakdown of material classes present in Fort Story collections at SouthArc.

Figure 86. Collections are stored on unsealed-wood shelves in a padlocked room in the basement.

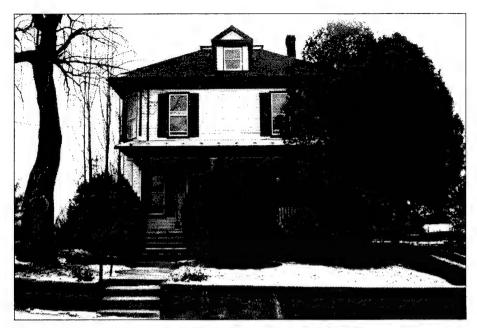
The building has a stone foundation with a concrete basement floor. Exterior walls have wood siding and the roof has shingles that were replaced in 1994. The building has a total of four floors—three above grade and one below-grade basement. Windows of various shapes and sizes are on all sides of the building, most without shades. Some of the windows and wood frames

Figure 87. Exterior view of the house where TAA offices are located.

have been replaced. Personnel have occasionally experienced draftiness and water leaks.

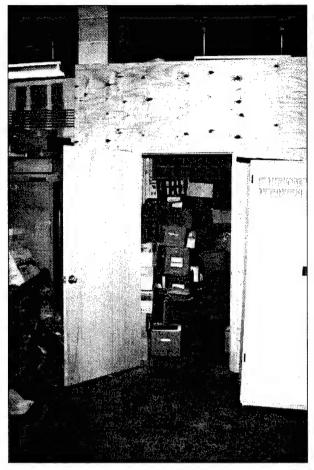
Figure 91. View of the collections storage area in Storage Location 2. Note that the walls do not extend to the ceiling and the boxes of collections are stacked haphazardly, causing damage.

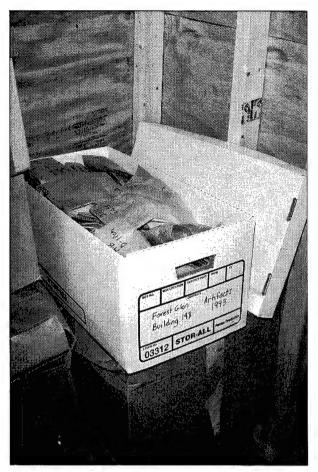
Figure 92. Acidic-paper bags are used as secondary containers for artifacts in Storage Location 2.

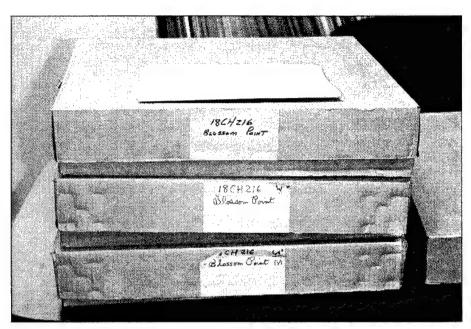
Figure 94. Examples of the primary containers used at UDCAR for artifact collections recovered from Blossom Point. The acidic-paper labels have been stapled to the boxes. The only associated documentation is in a single manila file folder on top of the boxes.

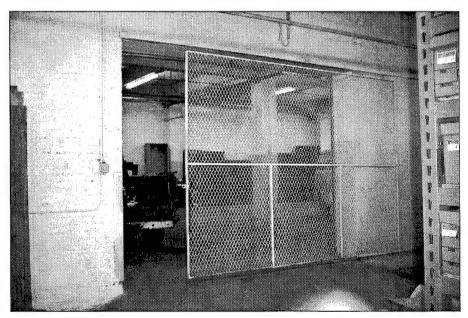
The offices are separated from the garage and the collections storage area by an interior metal-panel door. The collections storage area is secured from the rest of the repository by a northwest-facing rolling metal-mesh gate that extends from the floor to the ceiling (Figure 96). Within the collections storage area, there are eight windows, all facing to the rear of the facility (southwest), and one exterior metal-panel door facing the same direction. Two of the windows have wood frames, and six of the windows have metal frames. Metal-mesh grates are on the exteriors of all windows. There are no shades on the windows, but approximately three-quarters of them are opaque. The ceiling in the collections storage area consists of metal girders overlain by concrete.

Collections are stored under multiple overhead water pipes in the collections storage area; paint on the pipes is peeling and most pipes are rusted. Dirt and leaves are present throughout the collections storage area, especially in front of the rear exterior door. Dust is thick on the collections (Figure 97). Several glass window panes are broken. The impact of vehicle exhaust from the garage adjacent to the collections storage area on the collections is unknown. There is no solid wall or other form of environmental protection for the collections. The collections storage area is filled to approximately 50 percent capacity. The facility functions well as office and laboratory space, but rehabilitative measures need to be taken if collections are to be stored here long term.

Figure 96. The collections storage area is separated from the rest of the facility by a sliding gate.

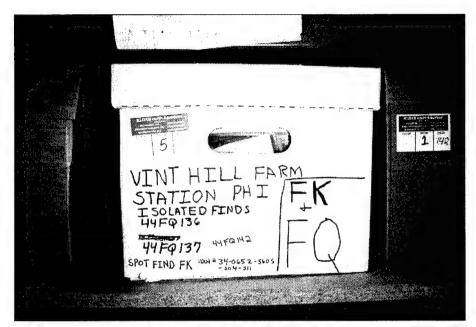
Figure 99. Example of the primary containers used to store collections. Cardboard boxes are labeled directly with black marker and stored on metal shelving units with particleboard shelves.

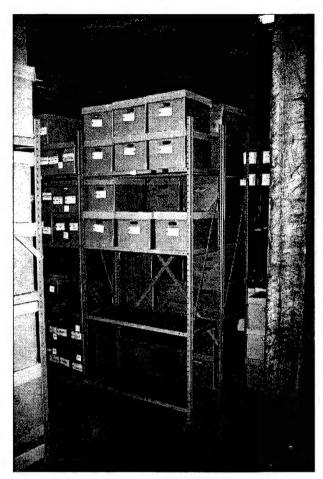
Artifact storage units in Storage Location 1 consist of open, enameled-metal shelving units that measure  $3.5 \times 1.5 \times 7$  feet (w × d × h) (Figure 101). Shelving units are numbered consecutively with adhesive tags attached to the top shelf of each unit. Artifact boxes are stacked two high on the shelves.

Figure 101. Metal shelving units, with boxes stacked two high, are used in Storage Location 1 for collections storage units.

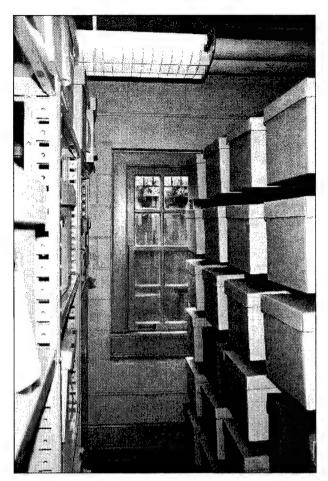
Figure 108. View of Collections
Storage Area 3. Note the close proximity
of the ground-level window to the
collections storage units.
